Inspector's Daily Report

IDR Sheet	1	of	1	Sheets	Final Record Book	Page	
Contract				Day		Date	
C-7852				Tuesday		August 17, 2010

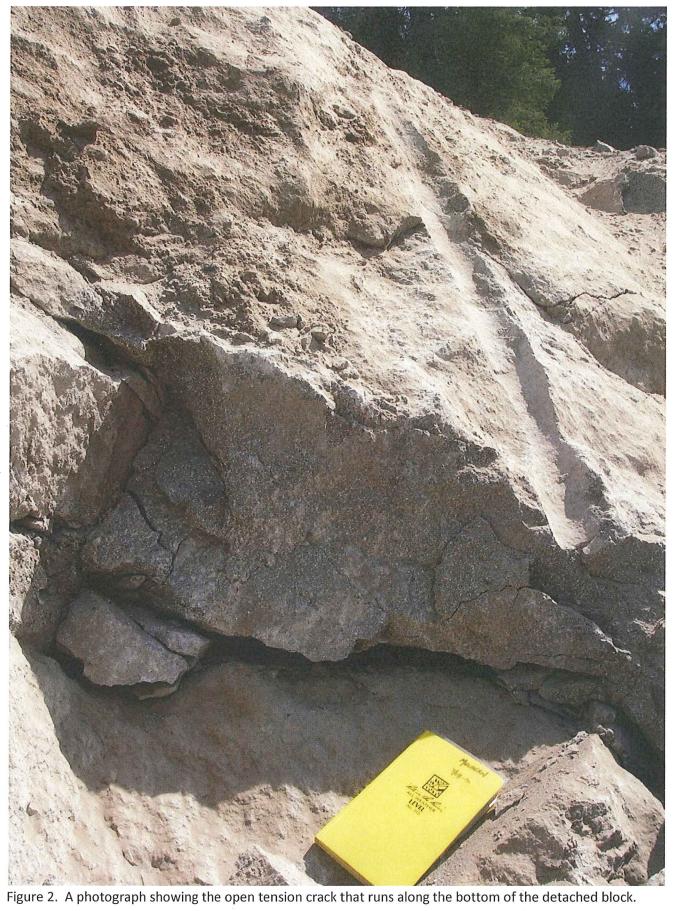
I met with Norm and Brad on-site to discuss the detached block located from approximate station LW 1335+75 to 1336+15. The detached block is approximately 40' long by 7' high by 4' thick (Figure 1). The west half of the block shifted down slope a couple of inches and a tension crack runs along the bottom of the block that is open about 2 inches (Figure 2). The east half of the detached block is buttressed by a bedrock protrusion that did not get shot during the previous night's blast (Figure 3). Norm and I discussed the options of removing or stabilizing the block before the next shot. I measured the dimensions and orientations of the block and indicated that I would analyze the detached block for needed reinforcement.

Figure 1. A photograph showing the detached block (red line) and the bedrock protrusion (blue line). The dashed red line assumes the tension crack continues behind the bedrock protrusion.
